A Guide to AFM Image Artifacts

Authors:
Paul West
Natalia Starostina

Version 1.2.

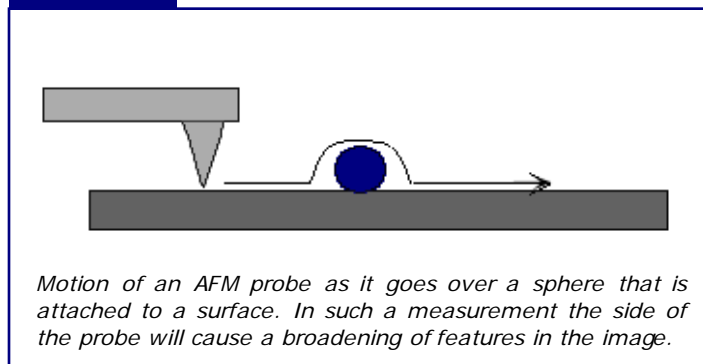
Figure 1

Often the size of features on the surface such as nanotubes or nanospheres look larger than expected. However, the height of the feature when measured by a line profile is correct.

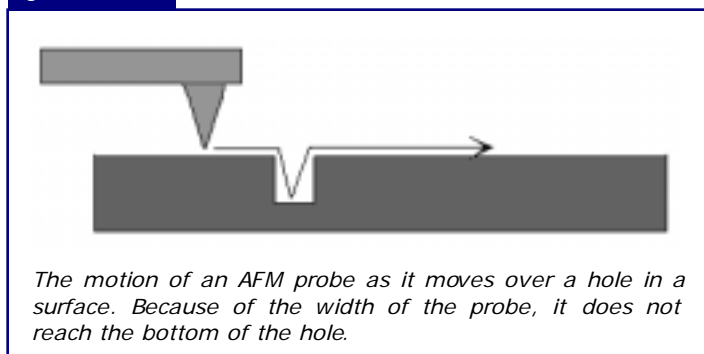
Figure 3

If the probe needs to go into a feature that is below the surface, the size of the feature can appear too small. The line profile in these cases is established by the geometry of the probe and not the geometry of the sample. However, it is still possible to measure the opening of the hole from this type of image. Also, the pitch of repeating patterns can be accurately measured with probes that don't reach the bottom of the features being imaged.

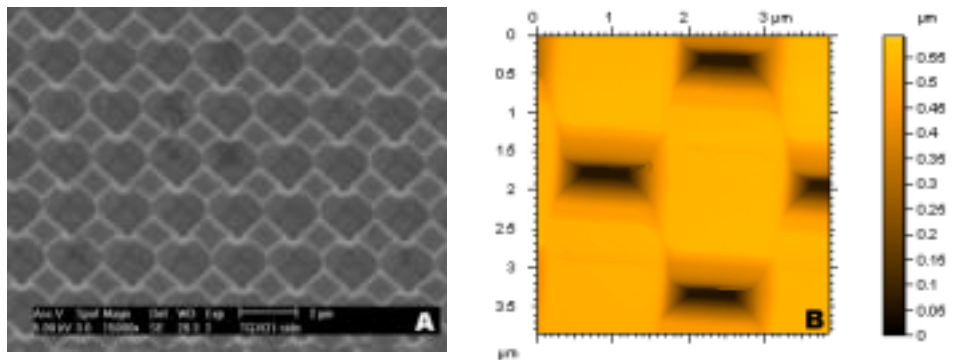
Figure 4

Scanning electron microscope image of a test pattern of squares (NT-MDT TX01) (A) The sides of the squares are all equal. (B) AFM image of the test pattern. Because the probe is not sharp, the test pattern squares appear much smaller than they should. The features in the AFM image appear as rectangles and not as squares.

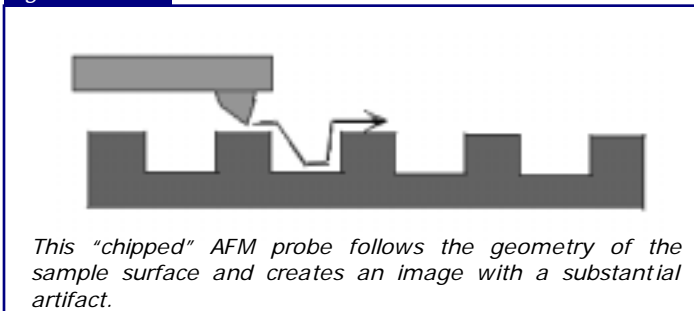
Figure 5

This "chipped" AFM probe follows the geometry of the sample surface and creates an image with a substantial artifact.

If the probe gets broken or chipped before an image is measured, strangely shaped objects may be observed that are difficult to explain. For example, when scanning a semiconductor test pattern, it can appear as though the tip is at a large angle to the surface as described in section 2.1. However, the probe to sample angle would have to be extreme to explain the image artifact.

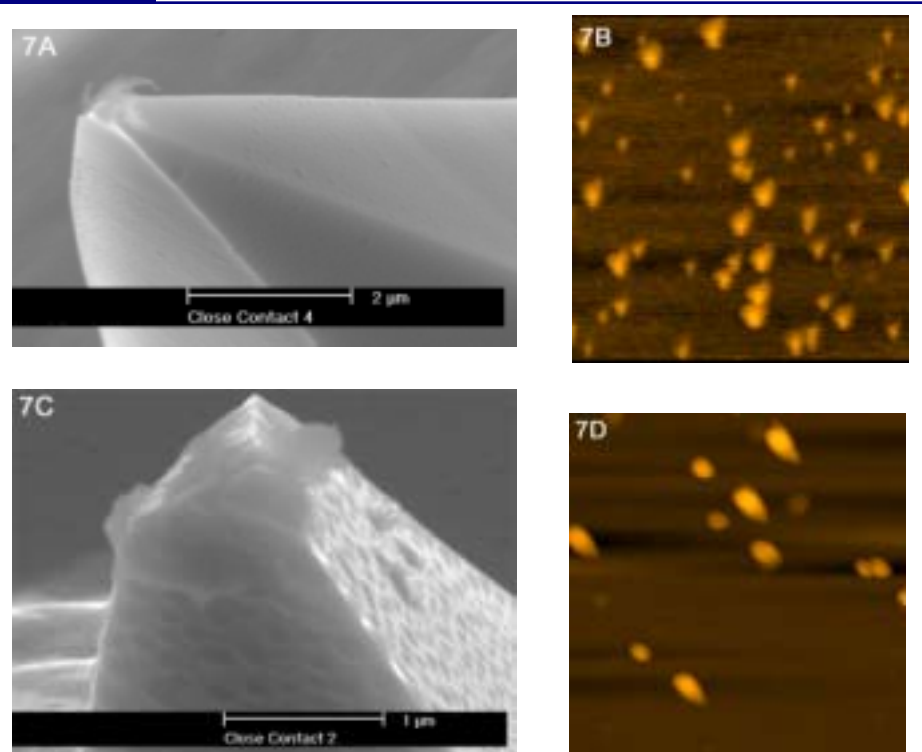
Figure 7

The AFM images at the right, B (5 nm in diameter) and D (28 nm in diameter), are of nanospheres that are supposed to be perfect spheres. At the right, A and C, are scanning electron microscope images of the AFM probes used for getting the images of the spheres. Because the chipped probes are much larger than the spheres, the AFM images reflect the probe's geometry. The scan size is 700nm X 700nm.

If the features on a surface are much smaller than the probe, then it is possible to see large numbers of repeating patterns in an image. The patterns will often appear as triangles, especially if silicon probes are used for imaging.

Example: Images of colloidal gold particles reflect the shape of the tip rather than their own geometry. Compare the SEM images of tips and related AFM images of spheres in the figures to the right.

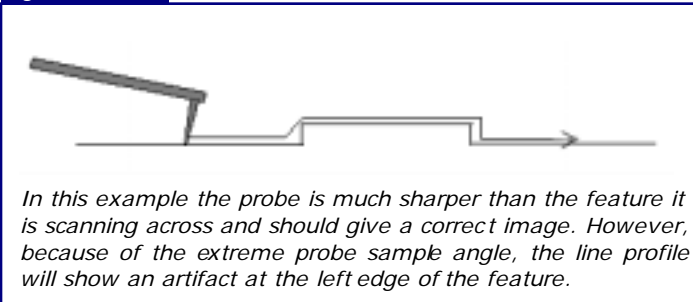
Figure 8

If the features that are being imaged by the AFM are much larger in profile than the probe, and the image does not seem "correct", the artifact may be caused by a non-perpendicular probe surface angle. Ideally, the probe of the microscope should be perpendicular to the surface.

Solving this problem is achieved by adjusting the angle between the probe and the sample so that they are perpendicular. In some microscopes the probe is designed to be at a 12 degree angle with respect to the sample. Also some AFM microscopes do not have mechanical adjustments to control the probe/sample angle.

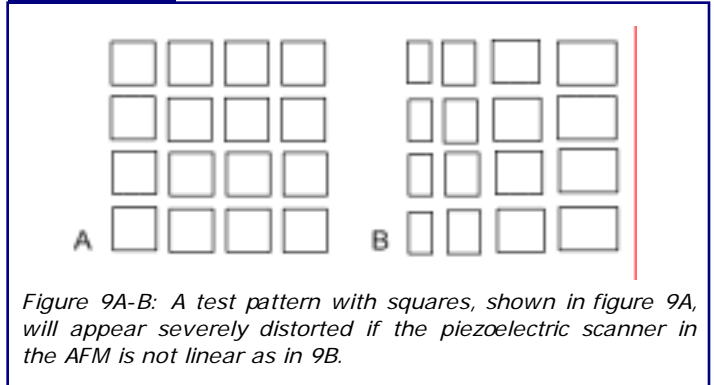
Figure 9

All atomic force microscopes must be calibrated in the X-Y axis so that the images presented on the computer screen are accurate. Also the motion of the scanners must be linear so that the distances measured from the images are accurate. With no correction, the features on an image will typically appear smaller on one side of the image than on the other.

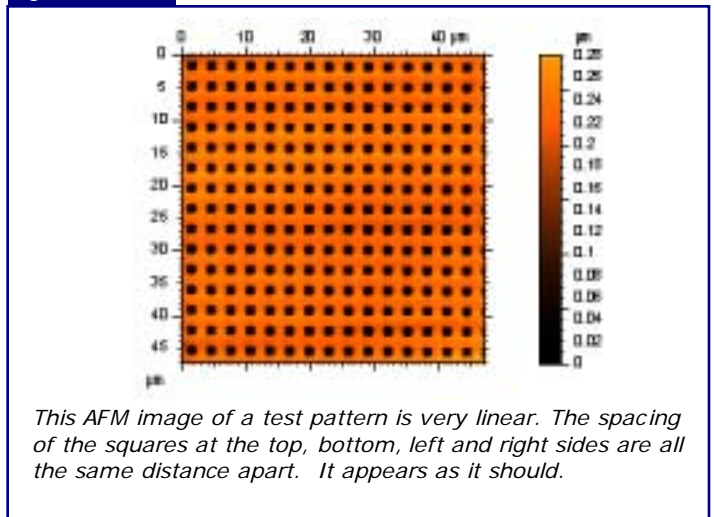
Figure 10

Once the scanner is properly linearized, it is also critical that the scanner be calibrated. For example it is possible for the scanner to be linear but not calibrated. If the calibration is incorrect, then the X-Y values measured from line profiles will be incorrect.

A common method for correcting the problems of X-Y non-linearity and calibration is to add calibration sensors to the X-Y piezoelectric scanners. These sensors can be used to correct the linearity and the calibration in real time.

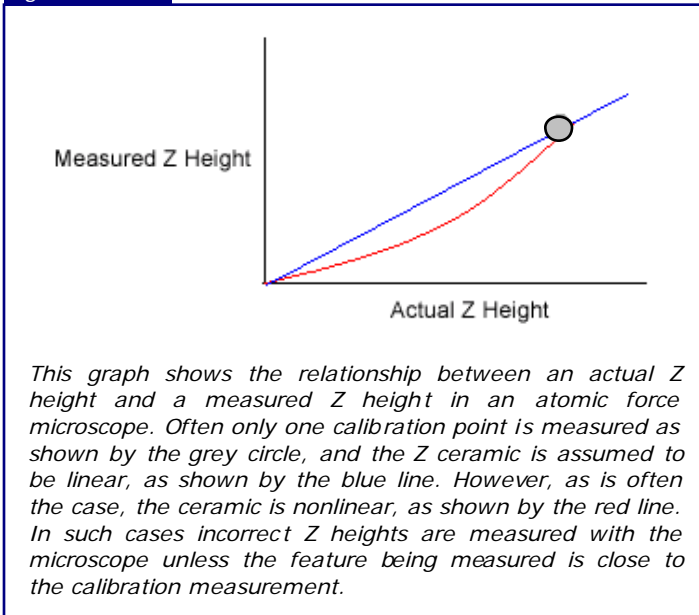
Figure 11

Height measurements in an AFM require that the piezoelectric ceramics in the Z axis of the microscope be both linear and calibrated. Often the microscope is calibrated at only one height. However, if the relationship between the measured Z height and the actual Z height is not linear, then the height measurements will not be correct.

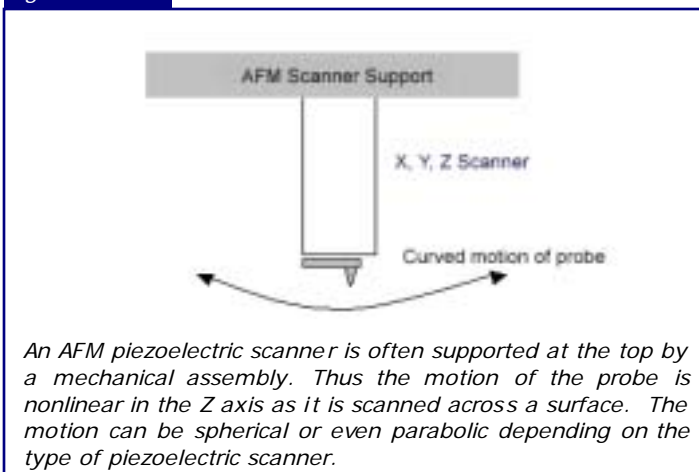
Figure 12

The piezoelectric scanners that move the probe in an atomic force microscope typically move the probe in a curved motion over the surface. The curved motion results in a "Bow" in the AFM image. Also, a large planar background or "Tilt" can be observed if the probe/sample angle is not perpendicular.

Often the images measured by the AFM include a background "Bow" and a background "Tilt" that are larger than the features of interest. In such cases the background must be subtracted from the image. This is often called "leveling" or "flattening" the image. After "leveling" the desired features are typically directly seen in the image.

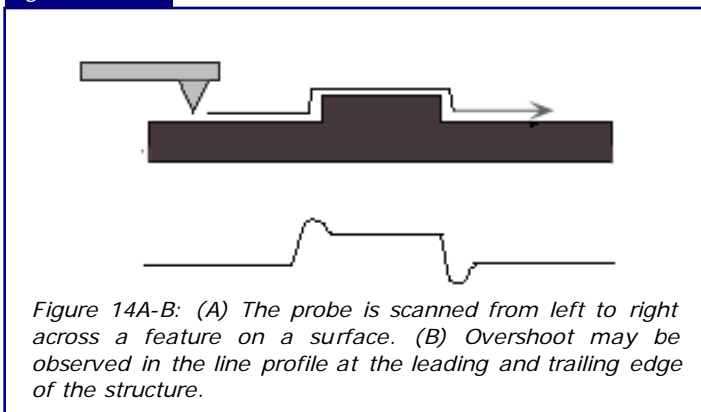
Figure 14

Hysteresis in the piezoelectric ceramic that moves the cantilever in the perpendicular motion to the surface can cause edge overshoot. This problem is most often observed when imaging micro-fabricated structures such as patterned Si wafers or compact discs. The effect can cause the images to be visually better because the edges appear sharper. However, a line profile of the structure shows errors.

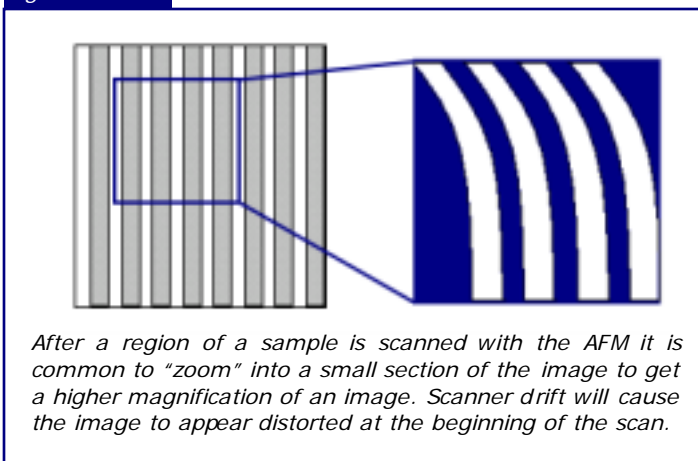
Figure 16

Drift in AFM images can occur because of creep in the piezoelectric scanner and because an AFM can be susceptible to external temperature changes. The most common type of drift occurs at the beginning of a scan of a zoomed-in region of an image. This artifact causes the initial part of a scan range to appear distorted. Drift artifacts are most easily observed when imaging test patterns. Drift will cause lines that should appear straight to have curvature.

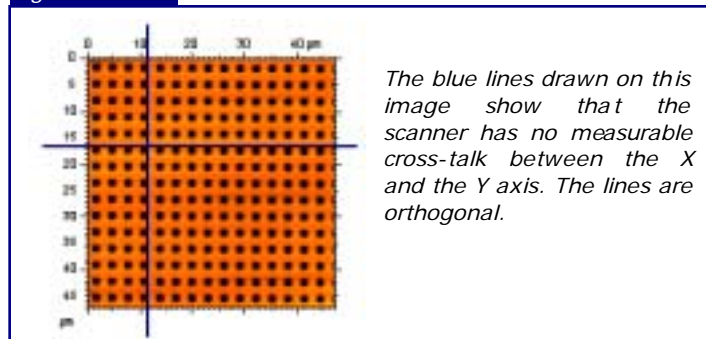
Figure 18

If the motion generated by the X-Y scanner is not orthogonal, then there can be errors in the horizontal measurements in an image. This error, or artifact, can best be seen when imaging a test pattern with squares. The error in orthogonality can be measured by using a straight edge to measure "orthogonal" lines in the images.

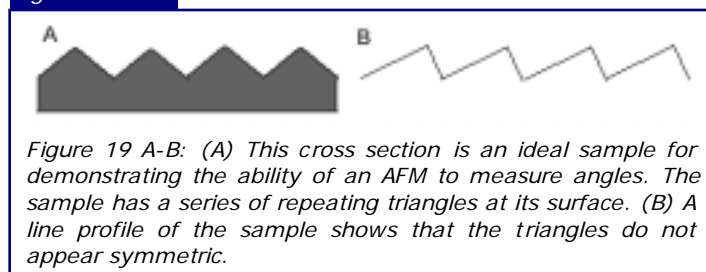
Figure 19

Mechanical coupling between the piezoelectric ceramics that move the probe in the X or Y directions and the Z direction can cause substantial errors when trying to measure side wall angles with the AFM. This error can best be measured with a sample that has repeating triangular structures.

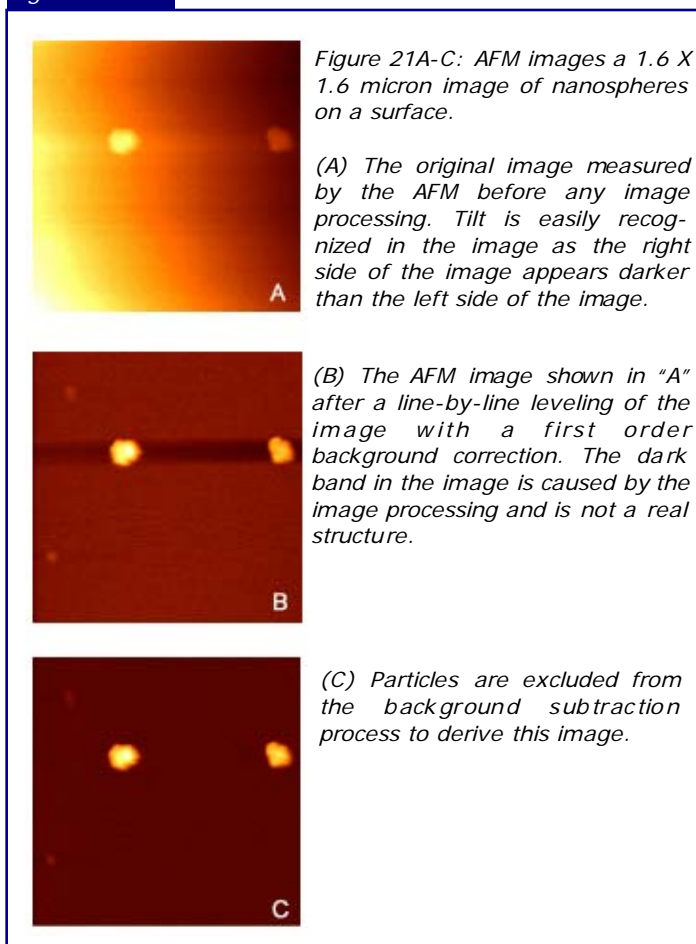
Figure 21

As mentioned in section 2.4, most images have some tilt and bow that is introduced to the images by the scanner or stage configuration. There are a number of background subtraction options that are possible. The two most common types are:

- Line by line leveling - 0 to 4 (th) order
- Plane Leveling - 0 to 4 (th) order

Also, software typically allows you to exclude areas from the leveling. When an area is excluded, it is not used for the calculation of the background in the image.

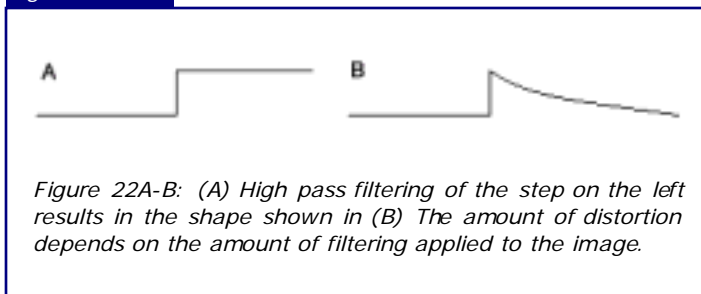
Figure 22

A low pass filter is often used to "smooth" data before it displays. Such filters can cause steps in images to appear distorted.

When images are viewed that have substantial low pass filtering, the dimensions in the image can appear distorted. Other artifacts can appear as a sharpness at the edge of steps in an image.

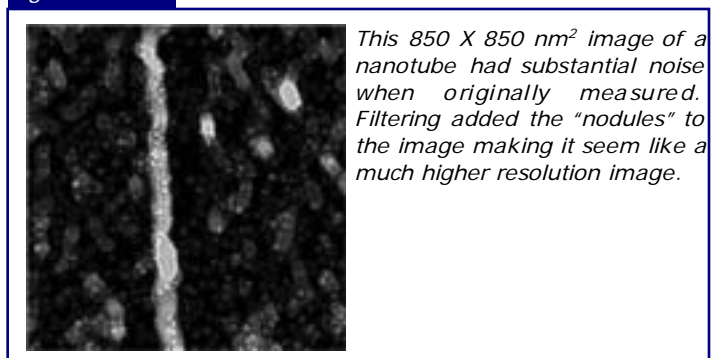
Figure 24

If an AFM image looks too good to be true it probably is. All measurement techniques have some noise associated with them. Because AFM data is completely electronic, it is possible to take an image and alter it with image enhancement techniques to create a beautiful picture that does not represent the structure of the surface.

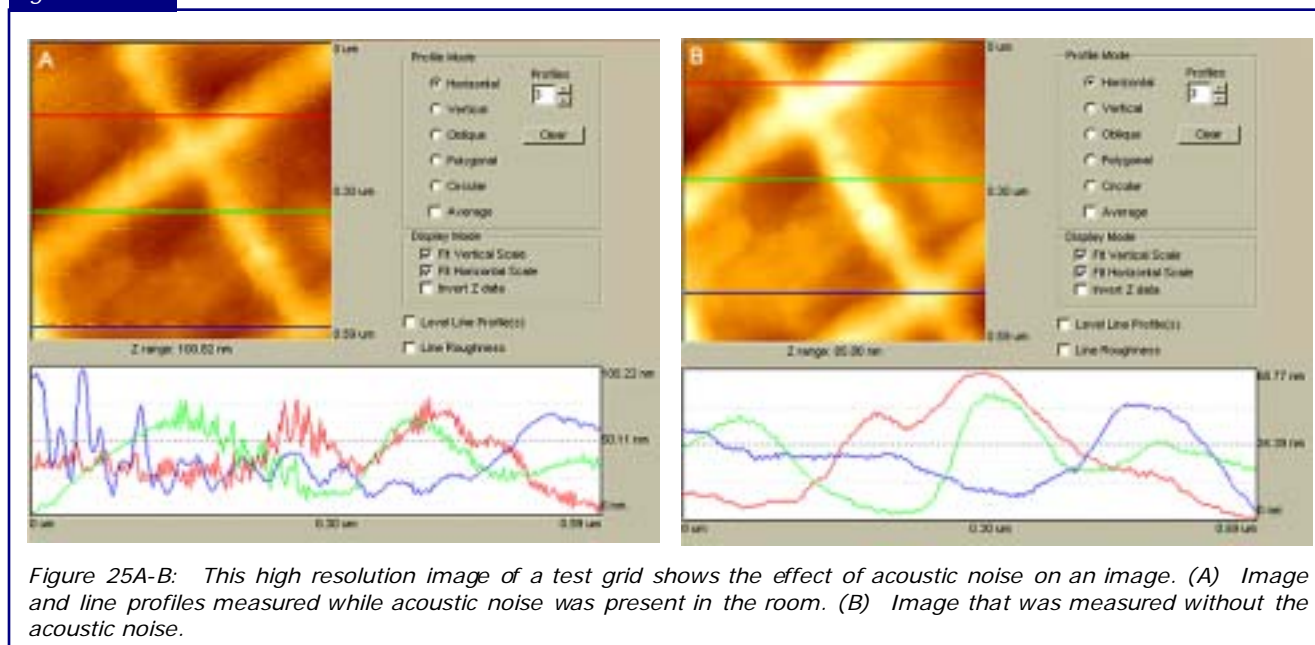
Figure 25

Sound waves can cause artifacts in AFM images. The source of the sound can be from an airplane going over a building or from the tones in a person's voice. Below is an image that shows the noise derived from a person talking in the same room as the microscope.

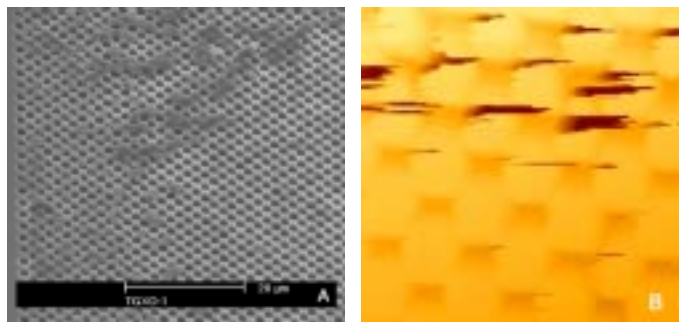
Figure 26

Figures 26A-B: (A) SEM image of a test pattern that is contaminated. (B) AFM image of the same test pattern that is covered with contamination. The contamination is identified by the streak marks at the top of the scan.

Substantial contamination at the surface of a sample such as a fingerprint or oil film can cause AFM image artifacts. Such artifacts appear as streaks on the image especially in locations where there are “sharp” features and edges on the sample's surface. Often the streaking can be reduced or even eliminated by cleaning the sample with a high purity solvent.

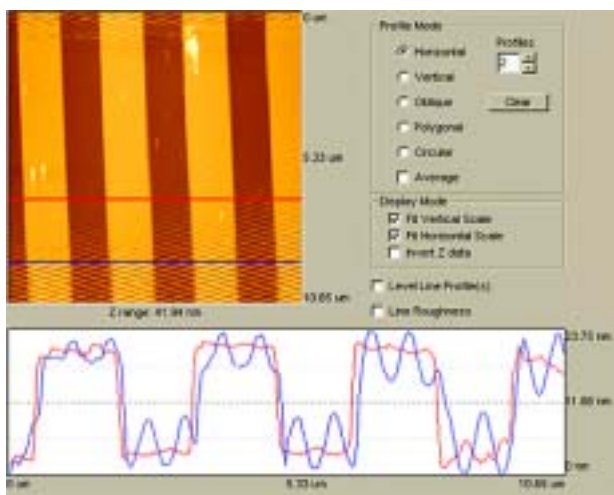
Figure 27

Image of a test pattern that has electronic noise at the top and bottom of the scan. The electronic noise in this case was a result of not having a ground wire attached to the stage. The artifact is identified by the oscillations.

Image artifacts can appear in AFM scans because of faulty electronics. Artifacts from electronics most often appear as oscillations or unexplainable repeating patterns in an image. Electronic ground loops and broken components are usually the source of electronic noise.
